# **COMMUNITY HEALTH EFFECTS RELATED TO EXPOSURES FROM CREOSOTE AND/OR CCA WOOD TREATMENT PLANTS**

Dr. A. P. Ryan

Department of Occupational and Environmental Health

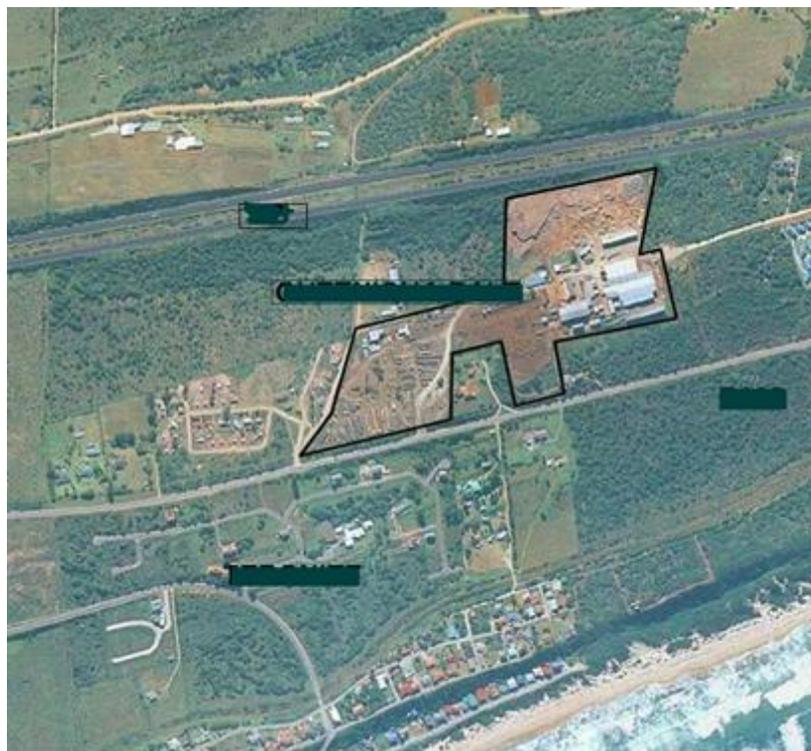
Fig 1 : Layout of the treatment plant

The treatment plant (T) is shown in figure 1 above. It is situated in a coastal area, between a large national highway to the north (A), an up-market seaside holiday and residential area to the south (B), separated from the plant by a secondary road, and a lower-income community to the west (C). The CCA and creosote treatment areas are located towards the eastern and western ends of the site respectively, as shown, with intervening land used for stockyards of treated wood, bark stripping and sawing areas and, in the southeastern corner, currently unused buildings.

The treatment areas are several hundred metres apart, as shown in Fig 1. The creosote treatment area consists of cylinders and storage tanks housed under corrugated iron roofing. Immediately adjacent, to the south, is a building housing the site managers' offices and eating and washing areas for staff, and to the west, the boiler. The CCA treatment plant is smaller, with a single cylinder and storage tank, and is less conspicuous from the road. There was extensive coating and pooling of creosote in and around the creosote plant area, and some pooling of CCA near the CCA treatment cylinder.
